FIELD TESTS OF SIX OFFSHORE
OIL CONTAINMENT BOOMS

P. R. Corpuz and R. A. Griffiths

Environmental Technology Branch
United States Coast Guard
Washington, DC 20590

Final Report
Part 1

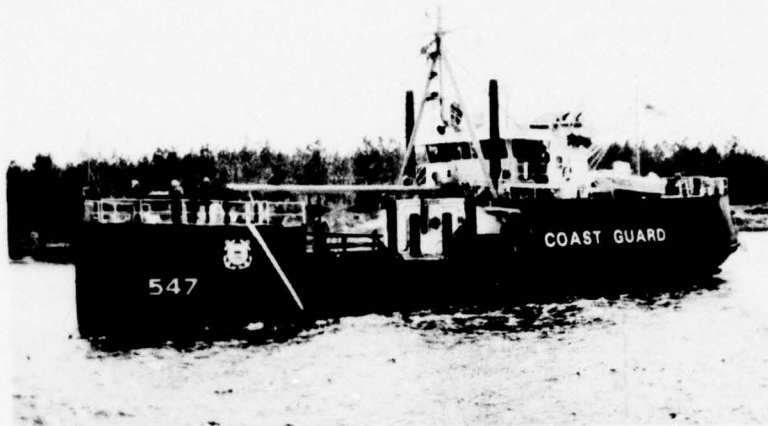
Figure 11. The USCGC WHITE PINE

The USCGC WHITE PINE (WLM-547) served as the main support vessel for the tests. The WHITE PINE (Figure 11) is a coastal buoy tender with twin screws, 40.5 m (133 ft) LOA, homeported in Mobile, Alabama. At various times during the test, the WHITE PINE set boom moorings, moved moorings, transported equipment and supplies, and deployed and retrieved the oil booms.

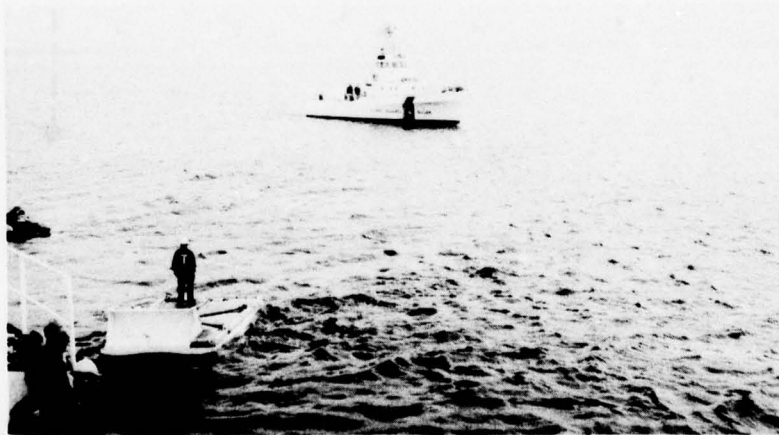
Figure 12. The USCGC POINT LOBOS

Regular support was also provided by the USCGC POINT LOBOS (WPB-82366). The POINT LOBOS (Figure 12) is a 25 m (82 ft) patrol boat homeported in Panama City. During the test, the POINT LOBOS towed booms to the test site and maneuvered booms for deployment, mooring, and retrieval. For various operations, a 41 ft (12.5 m) utility boat (USCG 41345) and a Boston whaler from the USCG Station Panama City lent further assistance. Two 16 ft (5 m) Zodiac boats were used for close work during mooring and inspecting.

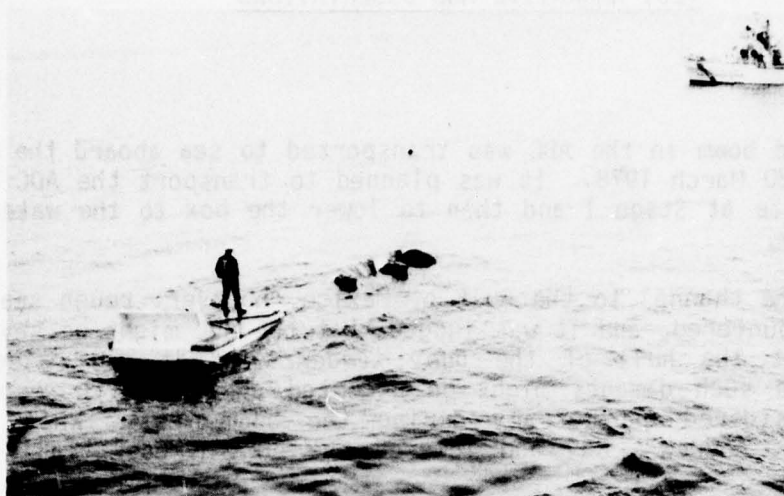
Figure 21. The Coast Guard boom being extracted from the ADC.

Figure 21 shows the boom being extracted from the ADC by the USCGC POINT LOBOS. A man is needed aboard the ADC to release the tailgate and assist in connecting the tow line. During extraction, four flotation bags failed to inflate. The CO₂ bottle on one of these four triggered but failed to inflate the bag due to an improperly tightened valve. The valve was corrected, and the bag inflated properly with a spare CO₂ bottle. The other three did not trigger during extraction, but inflated properly when triggered manually from a Zodiac boat.

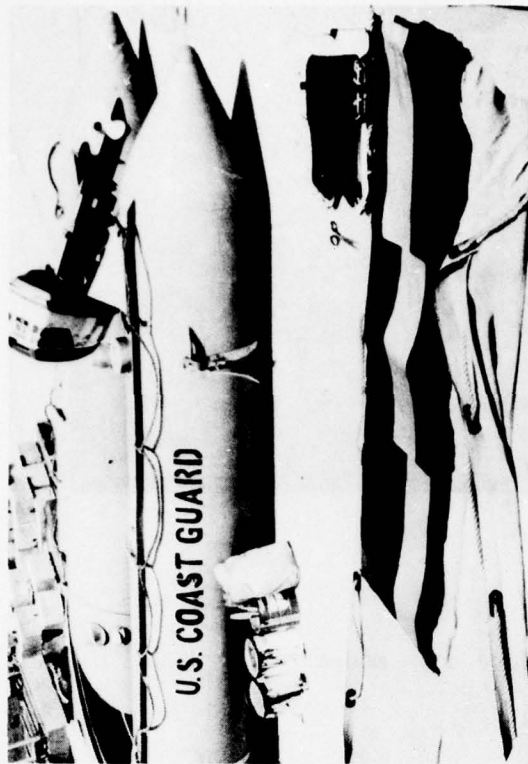
Figure 26. Video target painted on the Sjuntorp boom.

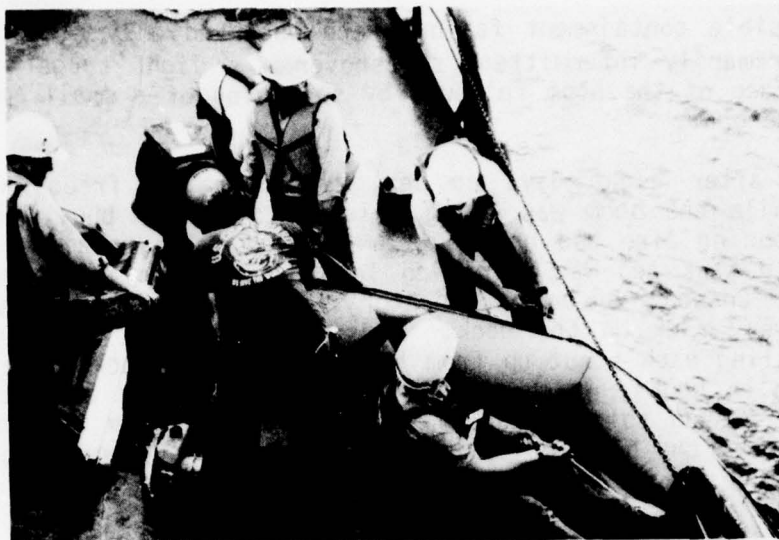
Figure 27. The Sjuntorp boom being inflated and deployed from the USCGC WHITE PINE.

The Sjuntorp boom was transported to the test site in a crate aboard the WHITE PINE on 30 March. Once on scene, deployment began directly from the crate on the buoy deck. Figure 27 shows the procedure for each section of boom. Most of the section was lowered over the side while a Zodiac boat pulled the free end away from the ship. A minimum crew of three was needed to haul on the boom, hold it, and inflate the section with the small gasoline powered blowers provided by A. B. Sjuntorp. A crew of five was generally used, however, to make the work easier and safer.

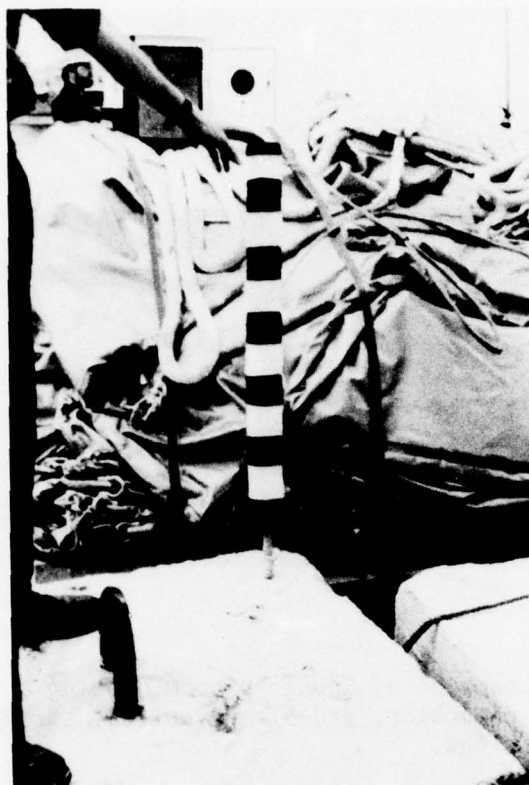
Figure 31. A "barber pole," which was attached to the bottom of the Sjuntorp boom skirt to attempt to observe the skirt motions.

The bottom of the dowel was fastened to the bottom of the skirt, and the styrofoam was slid up or down the dowel so that the pole would float almost vertically but not pull up the skirt excessively. This trick was also tried later with the Whittaker and Bennett booms; however, it failed and provided no useful information.

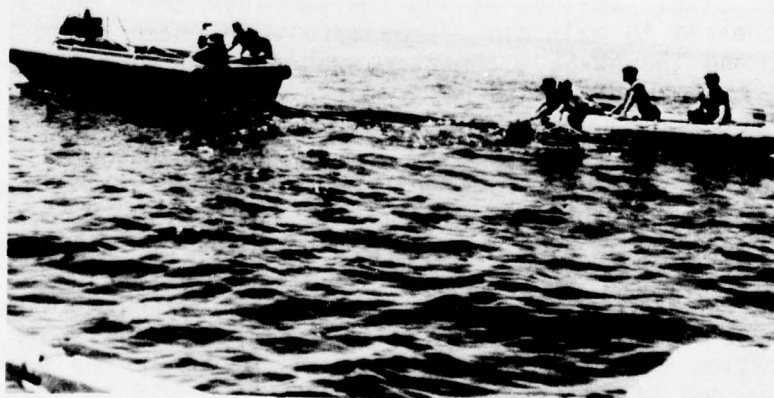
Figure 33. The Vikoma Seapack with the boom being deployed from the stern.

The boom was deployed from the Seapack with the assistance of Canadian Coast Guard personnel. The boom did not deploy automatically as the towing continued after releasing the backboard on the Seapack, however. An installation error resulted in premature inflation of the flotation cuff on the top of the boom, making it very difficult to complete deployment and causing a split seam on the cuff. A further complication was caused by a jammed mechanism in the Seapack which had to be forced physically before deployment could be completed. Rather than merely towing the Seapack to deploy the boom, a Zodiac boat assisted in extracting the boom, as shown in Figure 33.

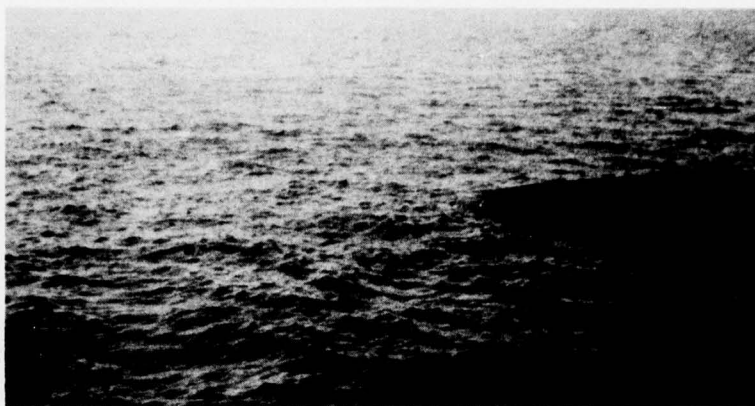
Figure 36. The Vikoma boom sinking after loss of power in the Seapack.

On 9 April, after one day at sea, problems began to occur in the Seapack. The diesel engine would not restart after being shut down for checks, and a cracked fuel line was found. Repairs were not completed until the next afternoon. The boom had begun to sink early in the morning, as shown in Figure 36, and the later attempt at reinflation brought about 90% of the boom back to the surface, but the remainder would not resurface. The repaired fuel line failed again after four hours, causing the engine to stop and aborting further attempts to raise the boom. During the afternoon of 10 April, another fuel line arrived from Canada, permanent fuel line repairs were completed, and another attempt to raise the boom was begun, with assistance from divers to remove a twist found below the surface. These efforts failed, however, and the boom was subsequently raised by releasing the moorings and towing the boom. The twist traveled down the boom to the end, and the boom was refloated and removed.

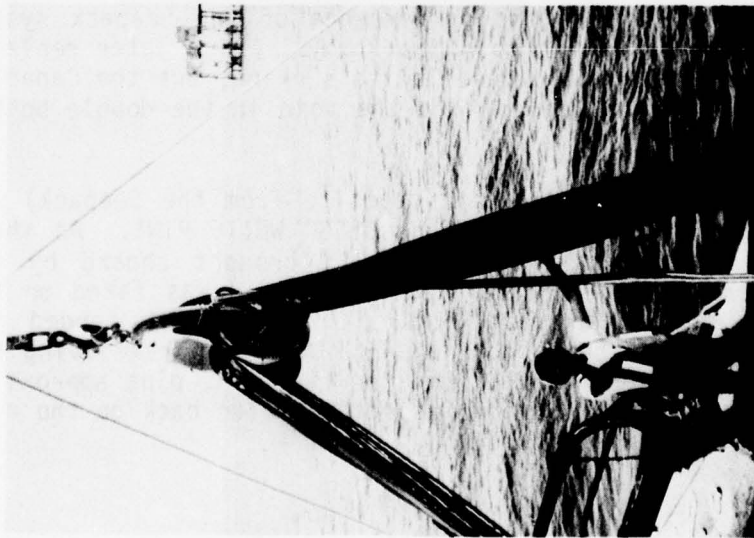
Figure 38. The Vikoma boom being retrieved through a Marco power block.

To recover the boom, the backboard-end (opposite from the Seapack) was released from its mooring and towed to the USCGC WHITE PINE. As shown in Figures 38 and 39, the boom was gradually brought aboard by the five-man buoy deck crew using a Marco power block and was faked on the deck for inspection and later repacking. A Zodiac boat tended the Seapack, which was also hoisted aboard WHITE PINE after retrieving the boom. The boom retrieval took 1 hr 07 min for five men, plus approximately 15 min for the Seapack. During inspection later back on the deck at NCSL, three minor tears were found.

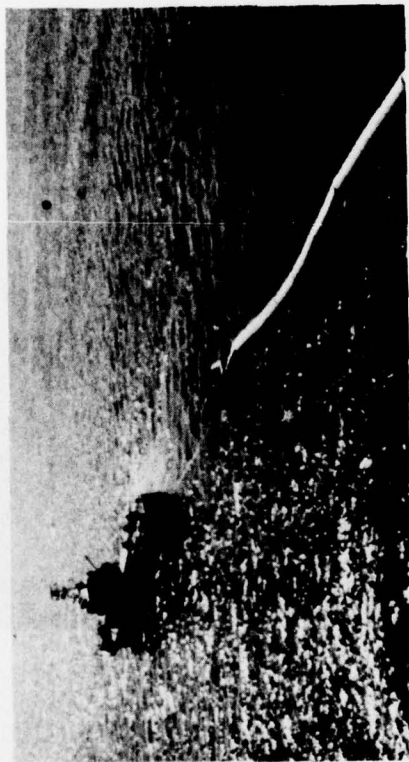
Figure 42. Mooring the Bennett boom at the test site. The steel buoys have been replaced by rubber fuel bladders.

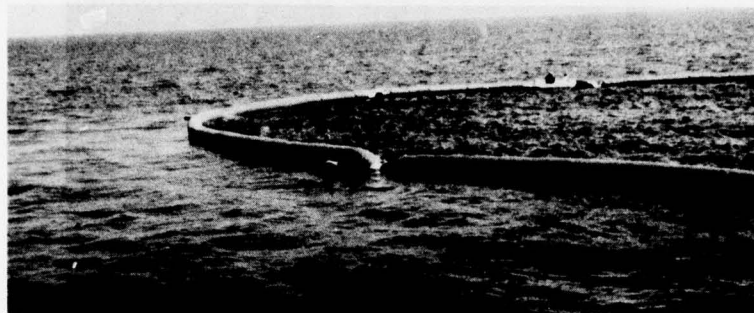
Figure 44. Crewmen in a Zodiac boat tending the Bennett boom, which is sinking at the connectors. A video target may be seen to the left of the Zodiac boat.

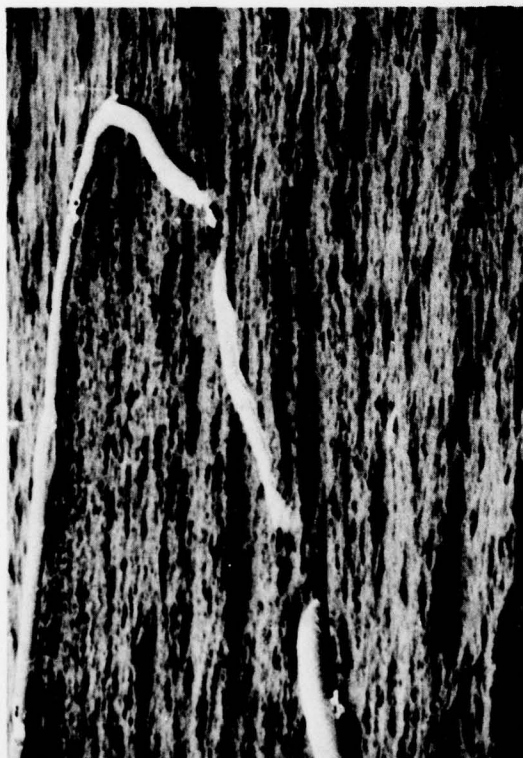
Figure 46. Air leaks in the Bennett boom connectors led to sinking.

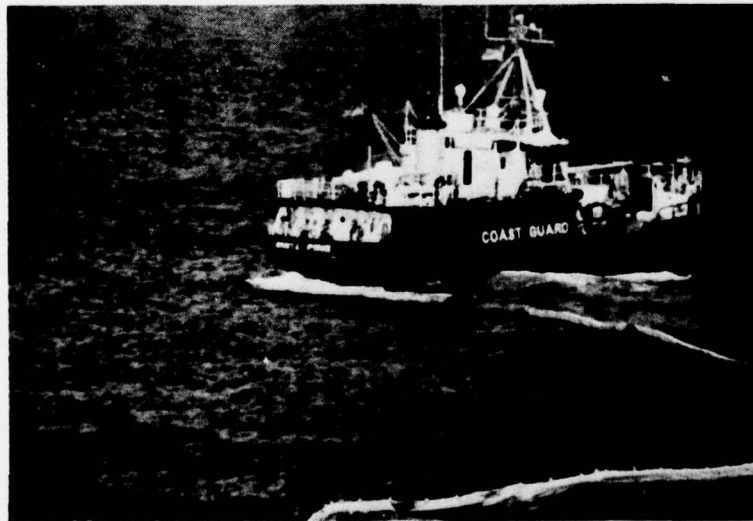
Figure 49. Whittaker boom being maneuvered near a mooring buoy.

In this case a slightly different mooring procedure was used in that WHITE PINE towed the boom past a buoy, and a Zodiac boat crew connected the free end. The end in tow was then drawn to the second buoy (Figure 49) and secured by the Zodiac crew. The Zodiac crew then proceeded to release by hand approximately ten of the self-expanding plastic frames that had not released during deployment.

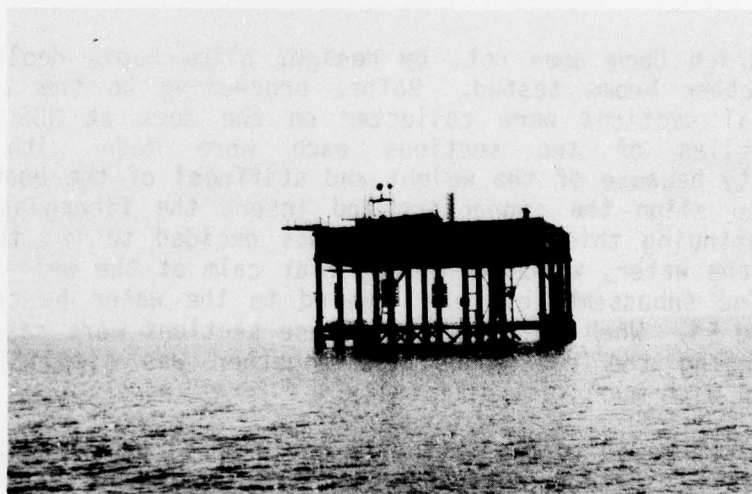
Figure 51. Stage I, the observation platform at the center of the test site, seen looking from the northwest

Stage I, shown in Figure 51, is operated and maintained by the U. S. Naval Coastal Systems Laboratory, Panama City, Florida. The platform is located in the Gulf of Mexico at 30-00-40 N, 85-54-20 W, as shown in Figure 10. It consists of three decks 32 m x 32 m (105 ft x 105 ft). The upper deck is approximately 17 m (55 ft) above mean sea level and includes a flight deck (helicopter landing pad) and an instrument house, built on the southern corner. The mean depth of the water is approximately 31 m (102 ft).

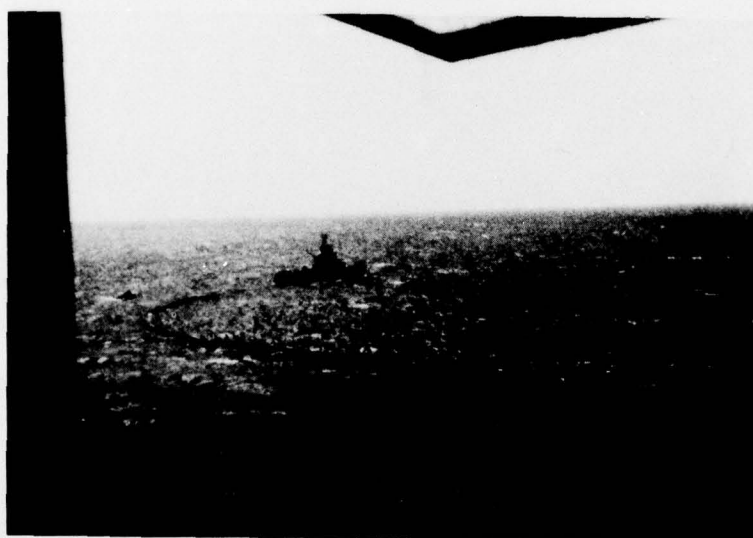
Figure 55. The USCGC POINT LOBOS maneuvering the Goodrich boom to the moorings.
